SUBJECT: Technical Assistance Report
The Pasion River Fish Kill Investigation
SESD Project # 15-0383

Technical Assistance Report

The Pasion River Fish Kill Investigation

Sayaxche, El Peten, Guatemala

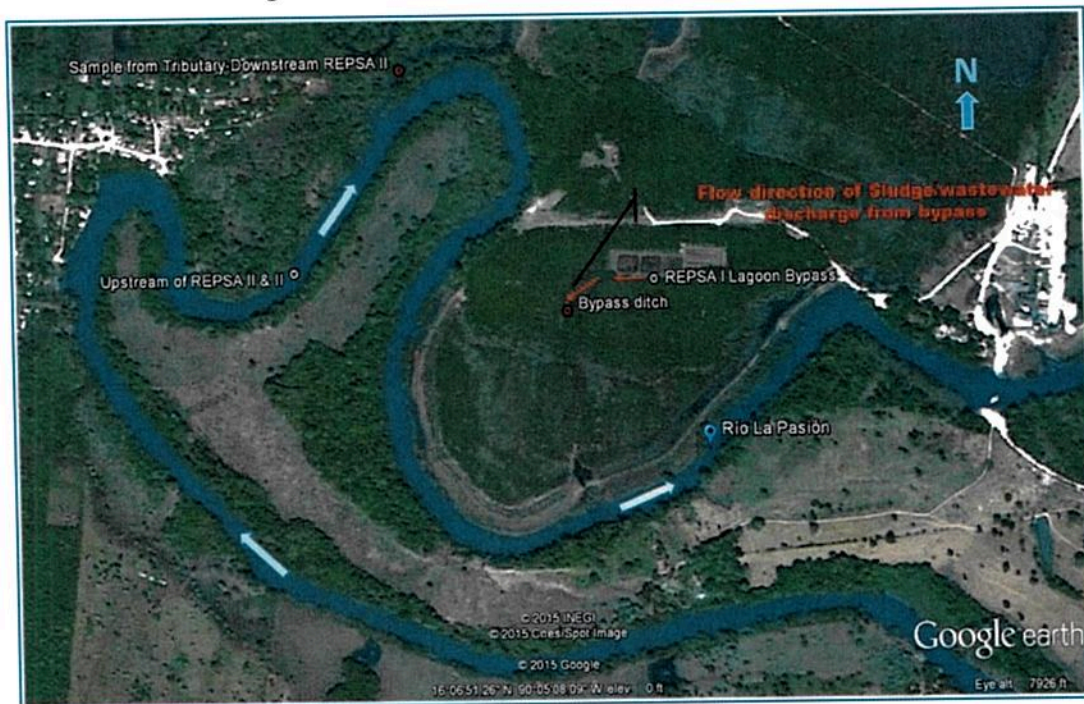
Figure 1: REPSA I Oxidation Lagoon Bypass Location

EPA observed that the wastewater/sludge discharged from the bypass pipe was dark gray in color and had an oily like appearance. Refer to Photos 2 through 5, pages 17-19, for details. **Figure 1** shows the location of the anaerobic lagoon bypass and the direction of the wastewater/sludge discharge.

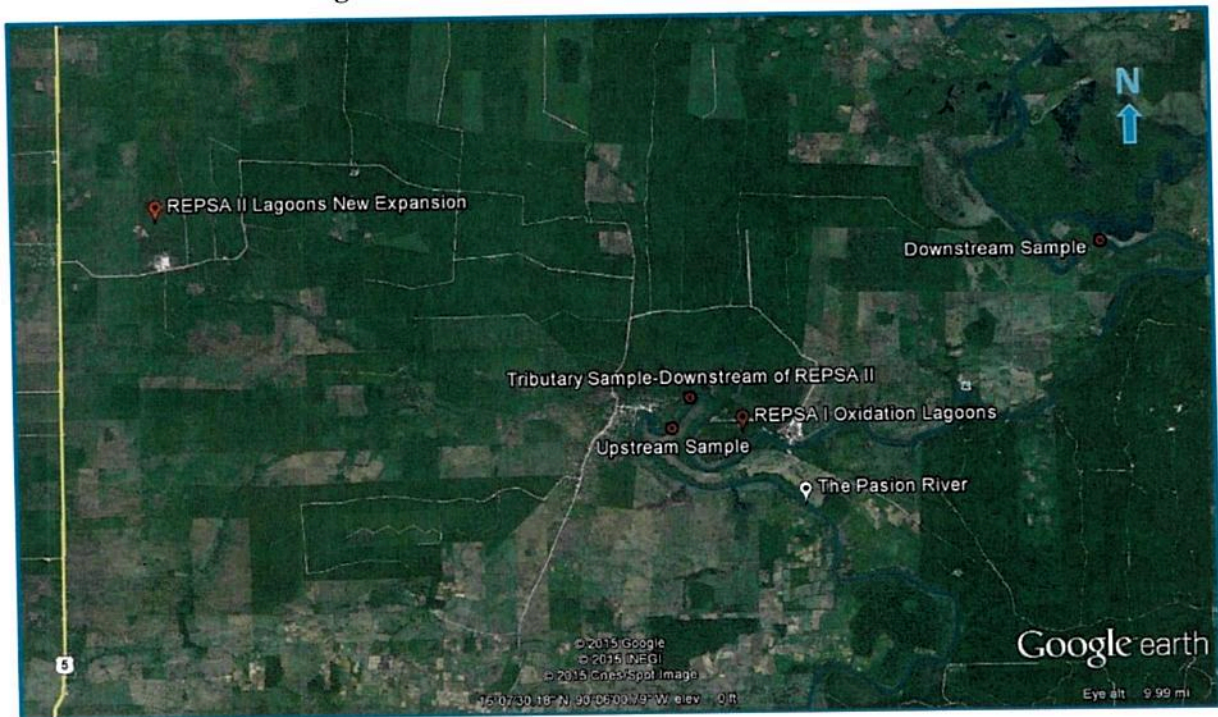
Figure 2: The Pasion River Sample Locations

MARN collected three surface water samples from the Pasion River (See **Figure 2**, page 9). Samples were collected for BOD₅, chemical demand oxygen (COD), TSS, metals, phosphorus, total nitrogen, oils and grease, fecal coliforms, total cyanide, and color analyses. Analytical results were not available at the time of the completion of this report. Upon completion of the analytical results, the results and their interpretation will be provided in an additional report. **Figure 2** describes the sample locations. **Table 2** includes the EPA field measurements collected in the three sampling locations.

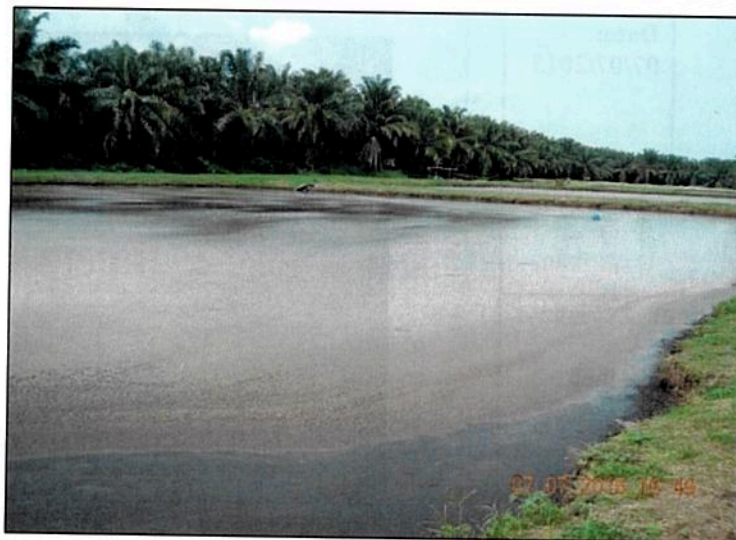
1

During the EPA visit, it was observed that the REPSA I lagoons were almost full to capacity, with a free board of approximately one foot (0.3 meters) (See photo 1, page 17). Typically, lagoons should have a minimum freeboard of 0.9 meters (3 feet) (USEPA, 2002). The minimum freeboard design criteria is recommended in an effort to avoid or minimize overflow during rain events of significant magnitude. In addition, EPA and MARN detected a very strong hydrogen sulfide odor similar to rotten eggs originating from the lagoon treatment system. At the time of the inspection, REPSA I was discharging untreated anaerobic sludge through a 15-cm (6-in) bypass pipe from the bottom of the anaerobic lagoon into an open channel area (See photo 2, Page 17). This bypass practice may short-circuit the hydraulic flow of the treatment process and

View of REPSA I's anaerobic lagoon where the bypass was observed. Lagoon was in full to capacity with a freeboard of approximately one foot.

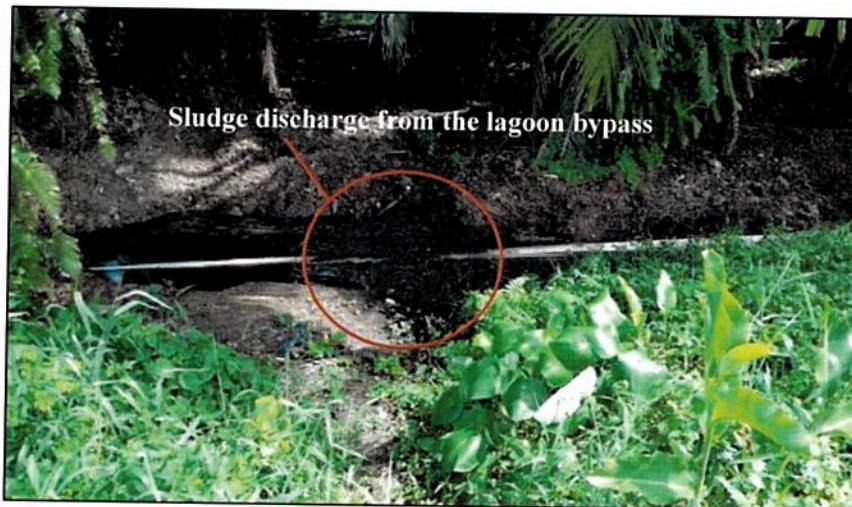
2

consequently adversely impact the overall treatment of the wastewater. Typically in this type of system, higher concentrations of contaminants are found in the bottom of the lagoon. Consequently, the bypass was discharging potentially the highest concentrations of contaminants outside of the wastewater reuse system. According to MARN's inspectors, REPSA also had not submitted to MARN its Environmental Assessment Instrument to evaluate the environmental impacts of its operations in the area, including an evaluation of the criteria used for the design of the oxidation lagoons. Since REPSA only had authorization to reuse the treated wastewater in the authorized irrigation fields, then this type of practice violated the Government Agreement 236-2006, Articles 34 (Wastewater Reuse Parameters), 55 (Disposal Prohibition of Wastewater), and 56 (Direct Discharge Prohibition), and therefore, can be considered an illegal discharge.

A dark brown, almost blackish wastewater/sludge is a sign of anaerobic conditions (low levels of dissolved oxygen) (USEPA, 1977). Wastewater generated from palm oil processing is also known as Palm Oil Mill Effluent (POME). POME, when fresh, is a thick brownish colloidal mixture of water, oil and fine suspended solids. It is hot (80-90°C) and possesses a very high BOD₅, which is non-toxic as no chemicals are added to the extraction process (Khalid & Wan Mustafa, 1992; Ma et al. 1993). POME is also acidic with a pH of around 4.5 (Madaki, Seng, 2013).

View of the bypass discharging anaerobic sludge into a ditch. The bypass was discharging sludge when EPA-MARN arrived at the plant.

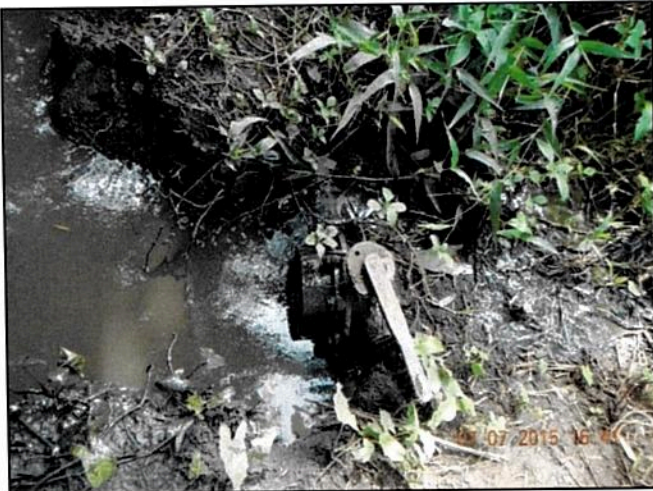
Direction Photo Taken: West			
Description: View of the six-inch bypass with the valve closed.

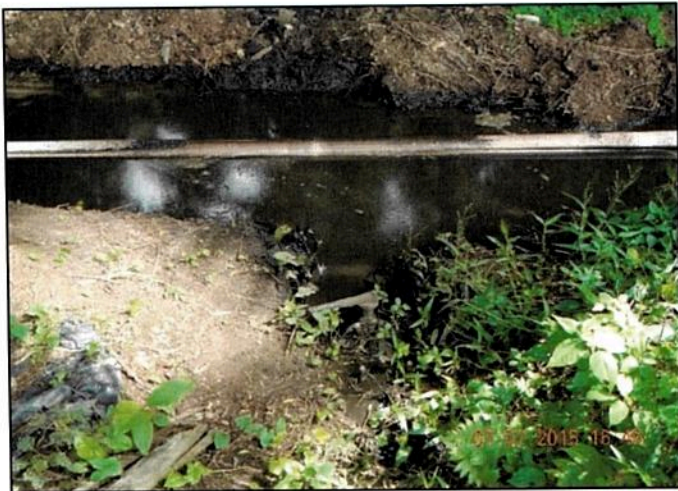
Direction Photo Taken: South			
Description: View of the stagnant sludge on the ditch after REPSA personnel closed the valve.

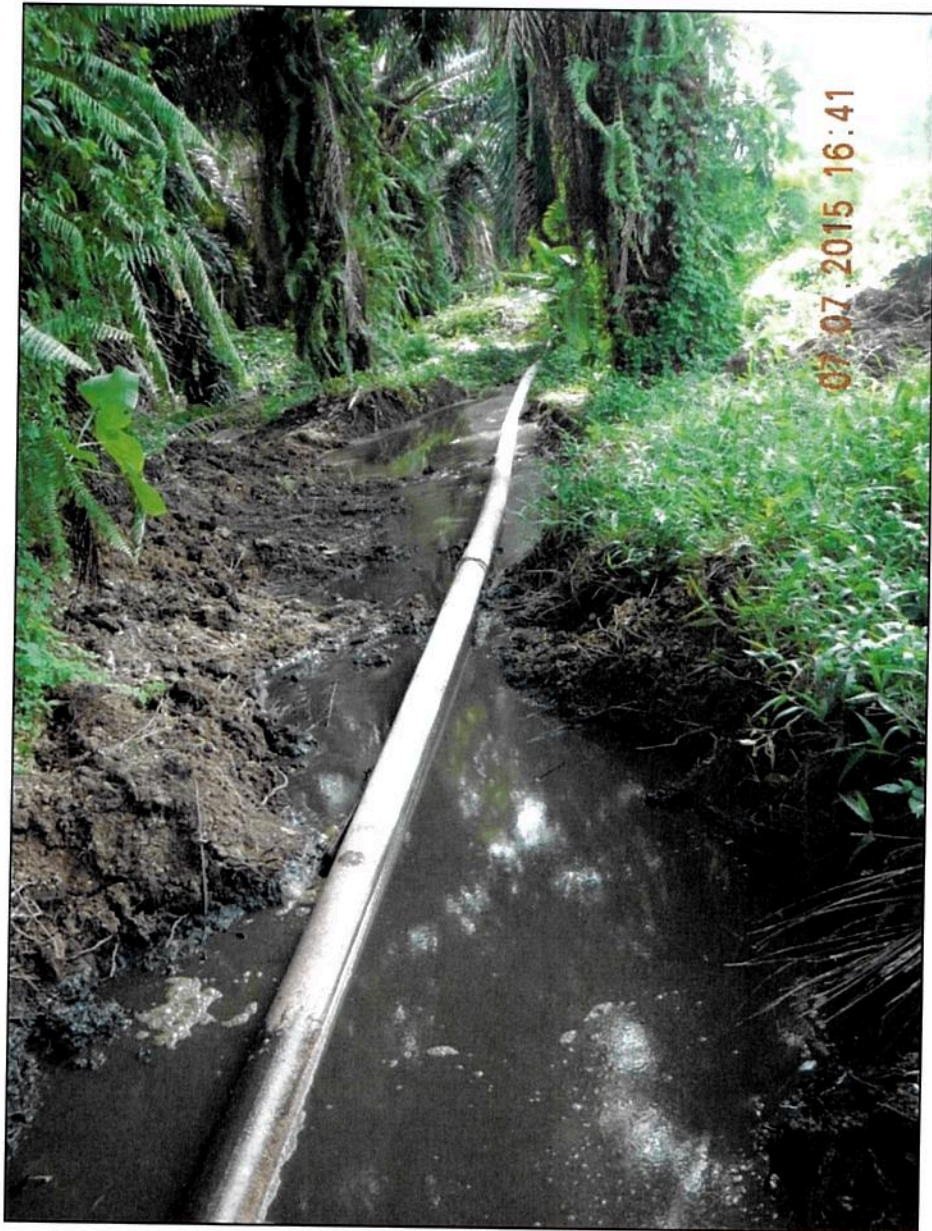
View of the drainage channel of the bypass flowing toward the southwest. The Pasion River is located approximately 400 meters toward the south of the lagoon bypass location. Runoff flows downstream towards the river.

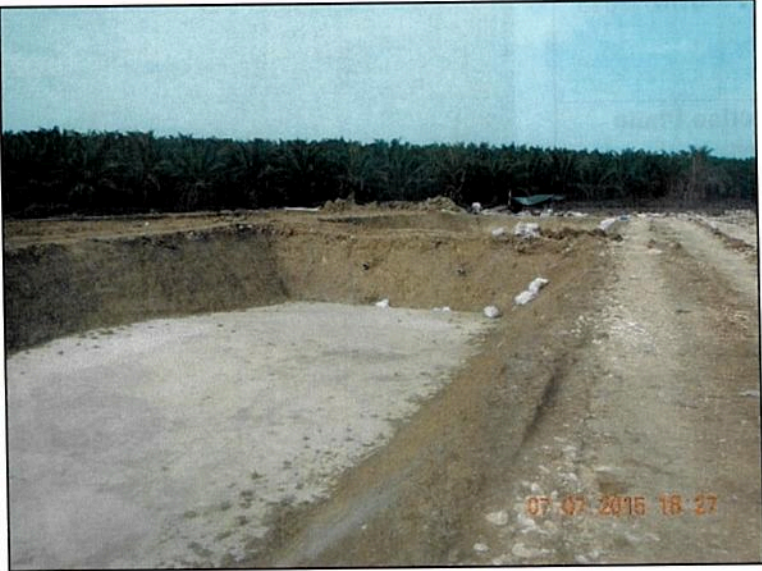
EPA and MARN also performed a walk-through to the REPSA II oxidation lagoon system. REPSA was expanding the lagoon system from nine lagoons to twelve new lagoons, for a total of twenty-one lagoons (See photos 6 through 8, pages 20-21). The system is composed of cooling lagoons, anaerobic and settling lagoons. The treatment system also included a 1,200 m³ digester lagoon for anaerobic sludge treatment. New lagoons were constructed with a concrete foundation. Eng. Edgar Moran stated that the construction of the new lagoons started on May 2015 (approximately two months before the EPA-MARN inspection). At the time of the inspection, REPSA II was put out of line because of the fish kill investigation conducted by MARN. The facility transferred part of the REPSA I wastewater generated from the palm oil manufacturing process to the REPSA II oxidation lagoon system. REPSA as a whole is planning to expand the production of palm trees from 150 hectares to 300 hectares in the coming years.

Direction Photo Taken: North			
Description: View of REPSA II expansion of the oxidation lagoons treatment system. A concrete slab was observed at the bottom of each new lagoon.

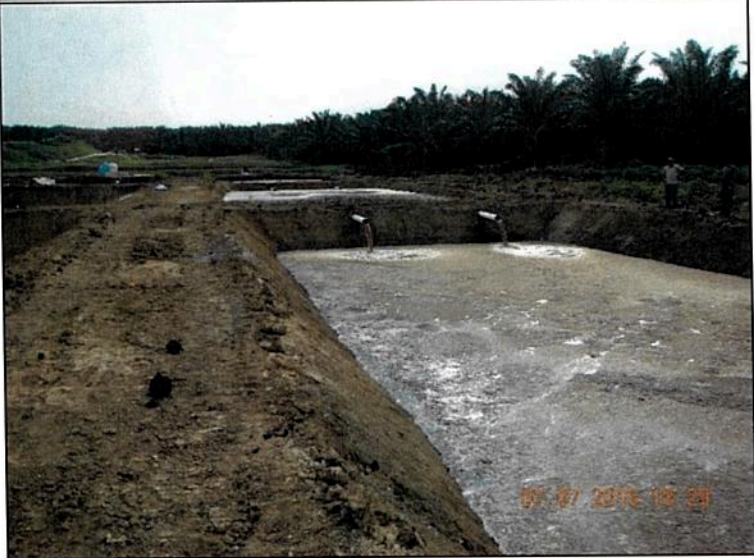
Direction Photo Taken: North			
Description: View of new anaerobic lagoon. REPSA I was transferring part of the wastewater to the REPSA II new plant.

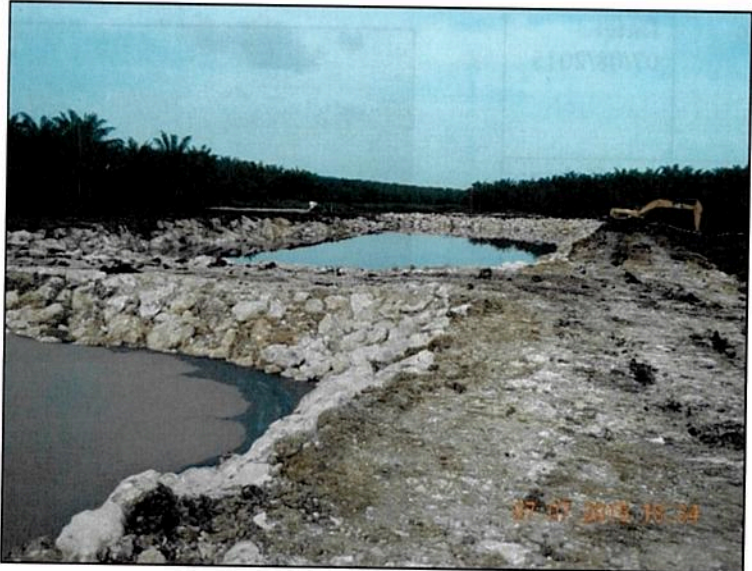
Direction Photo Taken: South		
Description: View of REPSA II's sludge digester lagoon (left) and final settling lagoon.

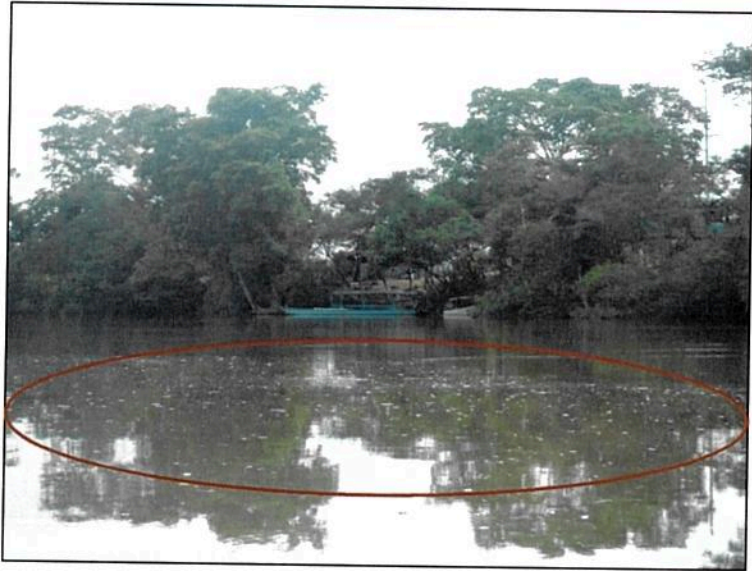
On July 8, 2015, EPA and MARN conducted a site reconnaissance on the Pasion River, near the cities of Sayaxche, El Ceibal, and Cedral. The river water appeared turbid. In addition, a large oil like sheen with debris was observed at the river water surface (See photo 9, page 21). EPA and MARN personnel observed sewage seeping from the ground and flowing directly into the Pasion River at the City of Sayaxche ferry area. (See photo 10, page 22). EPA also observed Sayaxche residents collecting water near the sanitary leaking area that reportedly will be used for some sort of human consumption (See photo 11, page 22).

Direction Photo Taken: North		
Description: View of debris accumulated in an oil sheen observed on the Pasion River. Surface water was observed turbid.

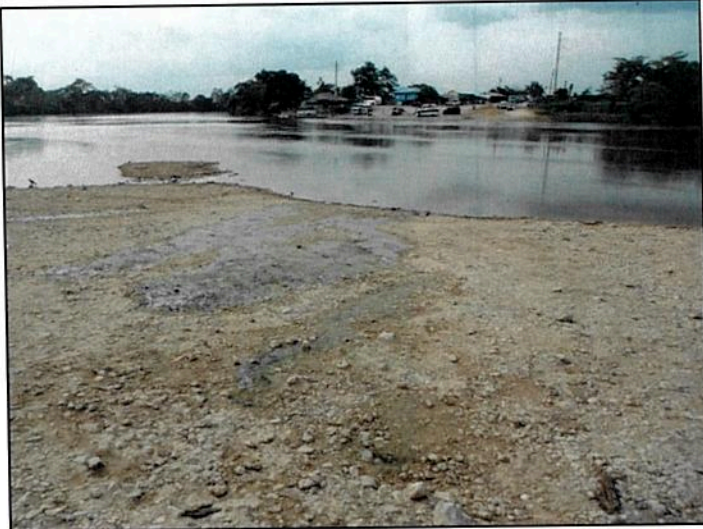
Direction Photo Taken: North			
Description: View of the sewage pipes seeping from the ground and flowing directly into the Pasion River. This was observed at the Sayaxche ferry area.

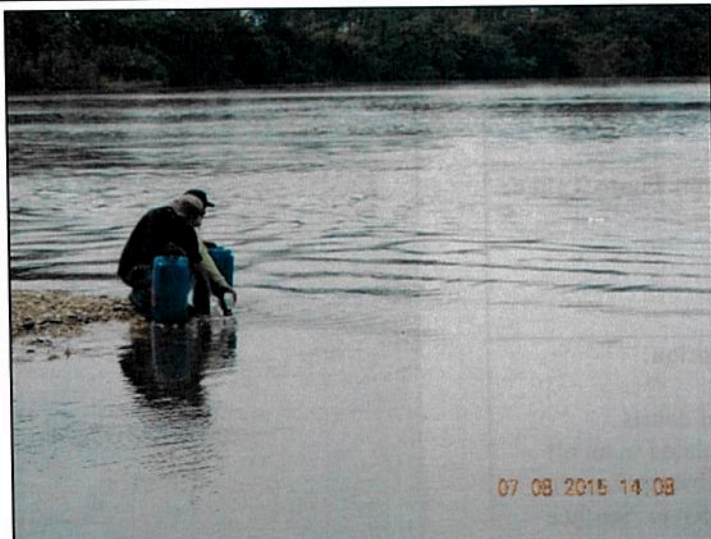
Direction Photo Taken: West			
Description: View of collection of water for human consumption near the sewage pipes location.
